## GROUP 4 DISASSEMBLY AND ASSEMBLY

### 1. BRAKE PUMP

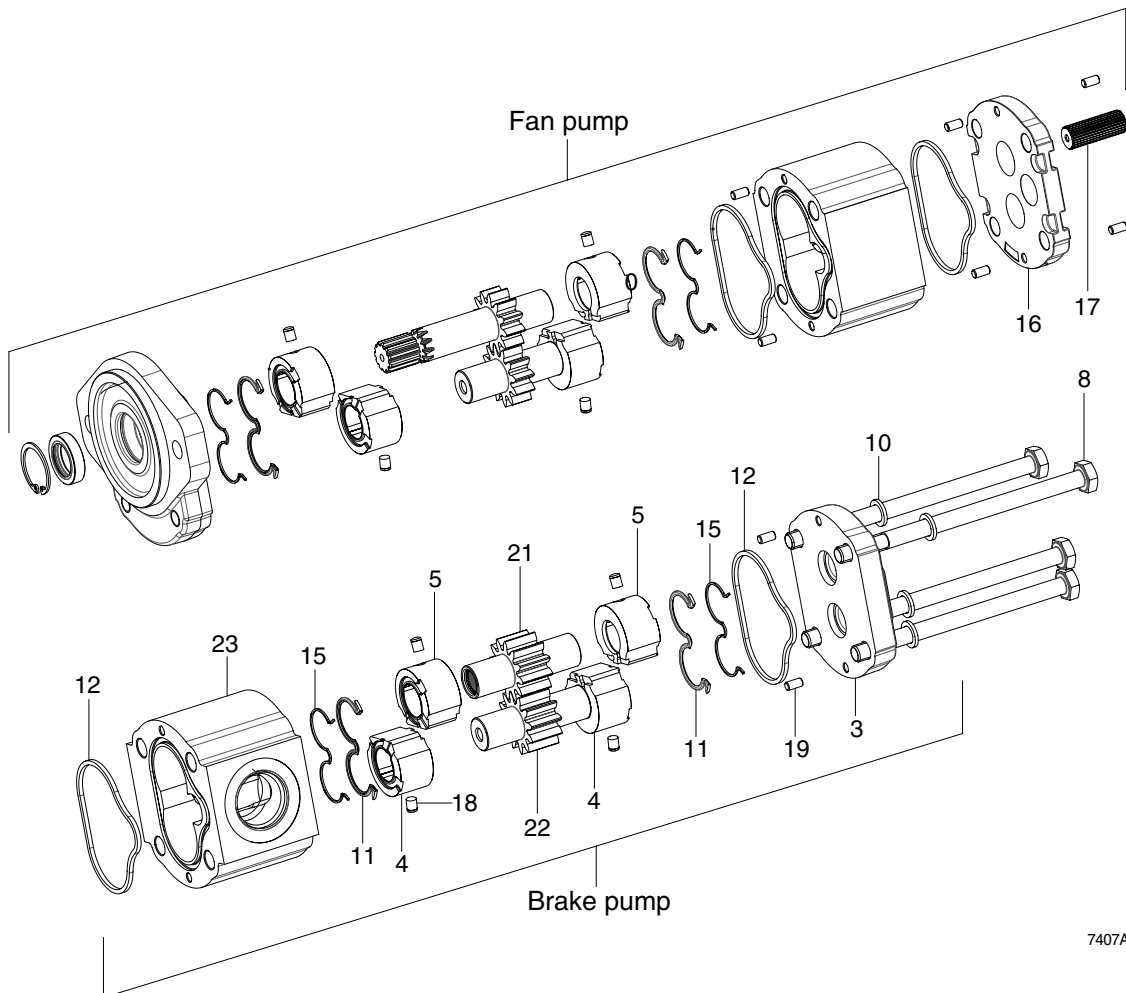
7407ABS19

#### 1) STRUCTURE

- |    |            |    |              |    |            |

| 3 | Rear cover | 11 | Seal | 18 | Spring |
| 4 | Plate | 12 | Seal | 19 | Dowel pin |
| 5 | Plate | 15 | Back up ring | 21 | Drive gear |
| 8 | Screw bolt | 22 | Driven gear | 23 | Body |
| 10 | Washer | 17 | Shaft | | |

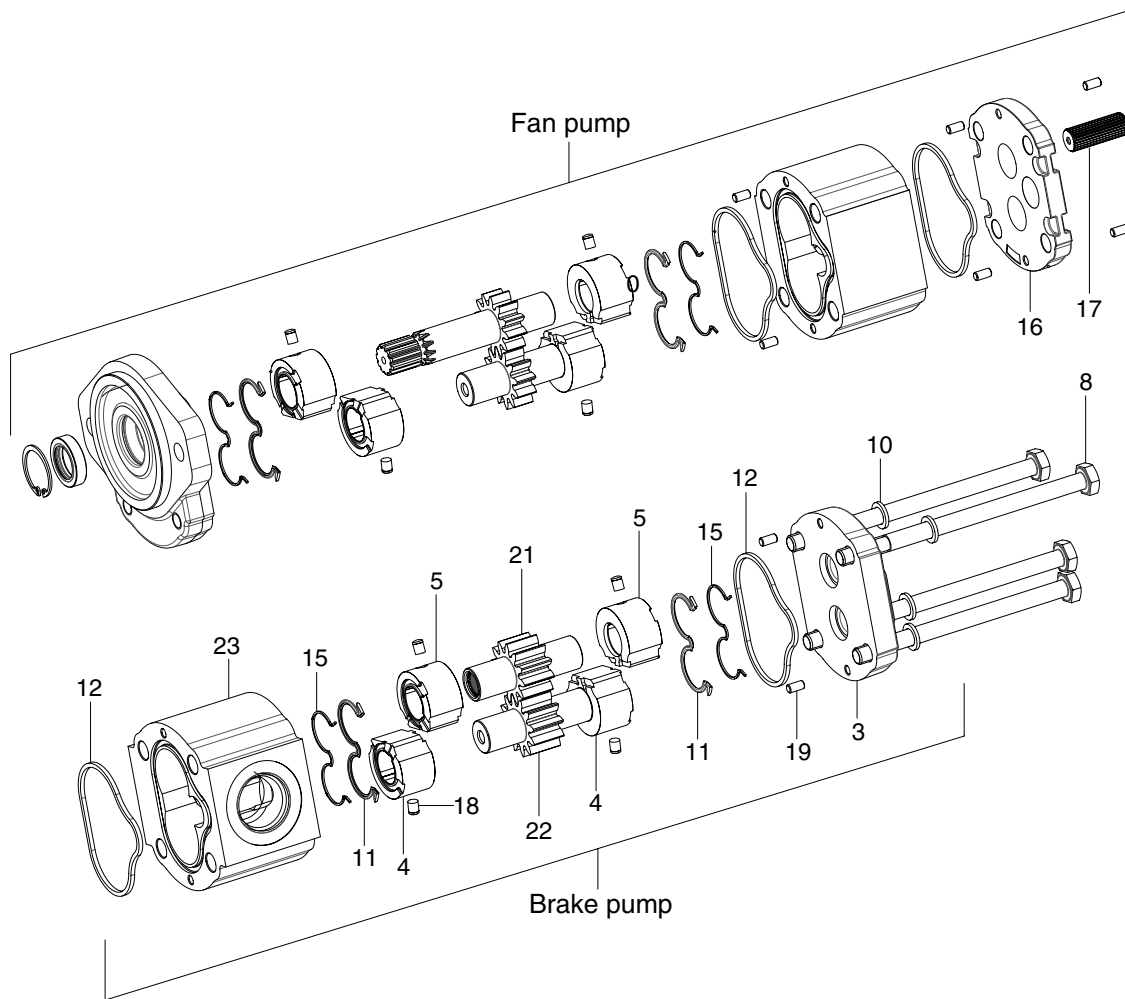
7407ABS19

- (1) Lightly mark the rear cover(3), body(23) and flange(16) to ensure reassembly in the correct position.
- (2) Remove the bolts(8) and separate the brake pump unit from the fan pump using a soft faced hammer.

- (3) Remove splined shaft(17).
- (4) Remove the flange(16) from the body(23), free from flange using a soft faced hammer.
- (5) Remove the back up ring(15), the seal element(11) and the body seal(12).

- (6) Remove the rear cover(3) from the body(23).
- (7) Remove the back up ring(15), the seal element(11) and the body seal(12).  
※ Before removing the internal components each plate(4,5) must be marked to denote its location within the body. On the plain area of the bush away from the seal location, lightly mark.

- (8) With the unit laying on its side grasp hold of the drive gear(21) and pull it squarely out of the body(23) bringing the plate(4,5) with it.
- (9) Remove the driven gear(22) and the remaining plate(4,5).

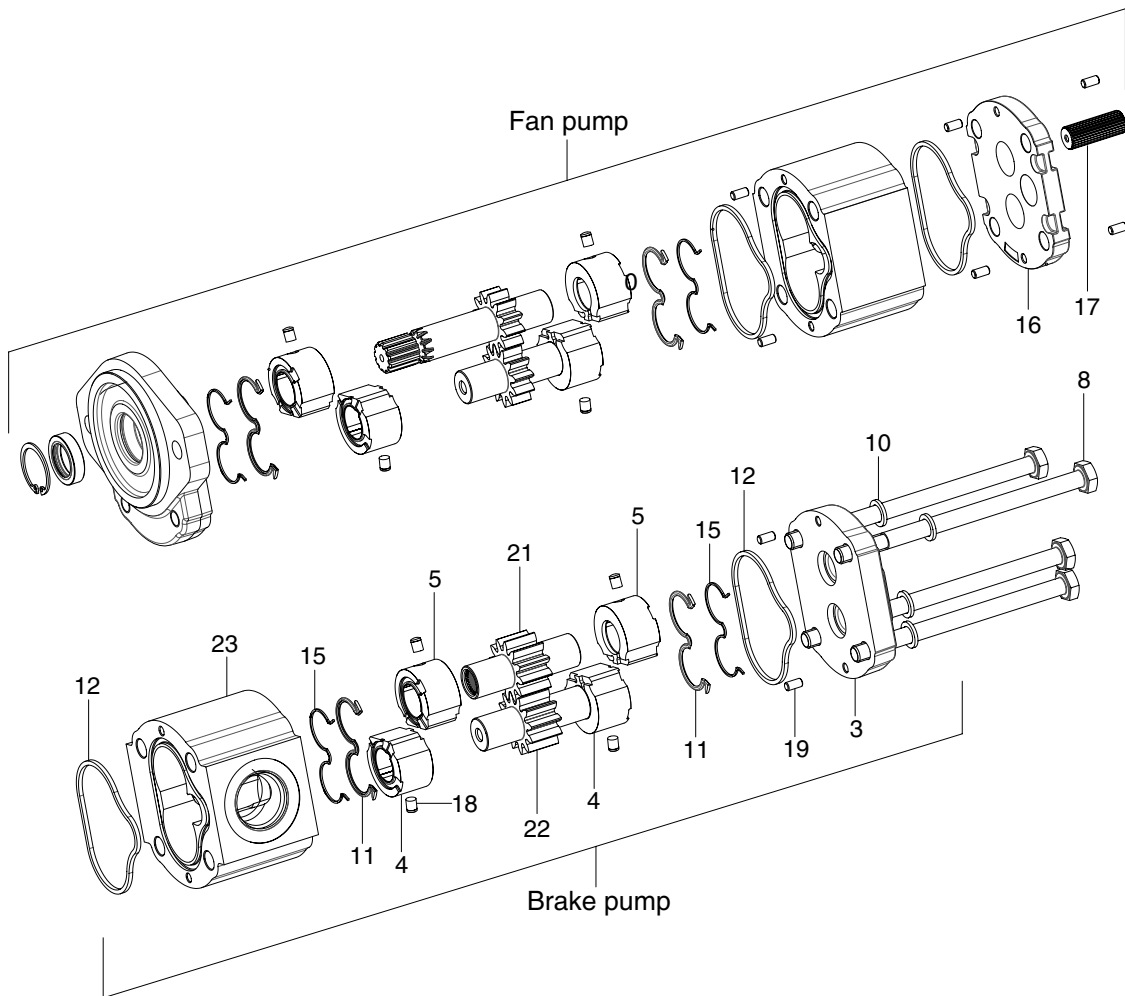
7407ABS19

※ Ensure that all parts are perfectly clean and lightly lubricate the bushes and gears with hydraulic oil (Ensure body seal recess and end faces remain free from oil). This will assist with their assembly when they are later fitted into the body.

- (1) Refit the plate(4,5) into the undowelled end of the body(23) from where they were removed.
- (2) Place the rear cover(3) against the body(23) and then stand the assembly on the cover so that the hollow dowels are uppermost, i.e. the plate should be at the bottom with the plates against the cover.
- (3) Fit the drive shaft(21) and driven gear(22) back into their original positions in the body(23).
- (4) Refit the plate bushing(4,5) into their original bores.
- (5) Fit the new body seal(12).
- (6) Fit the new seal element(11) and back up ring(15) to the plate.
- (7) Carefully refit the flange(16) to the body(23). If the flange(16) is not fitted squarely the seal(11) may become misplaced and trapped, resulting in internal damage if the unit is run in this condition.

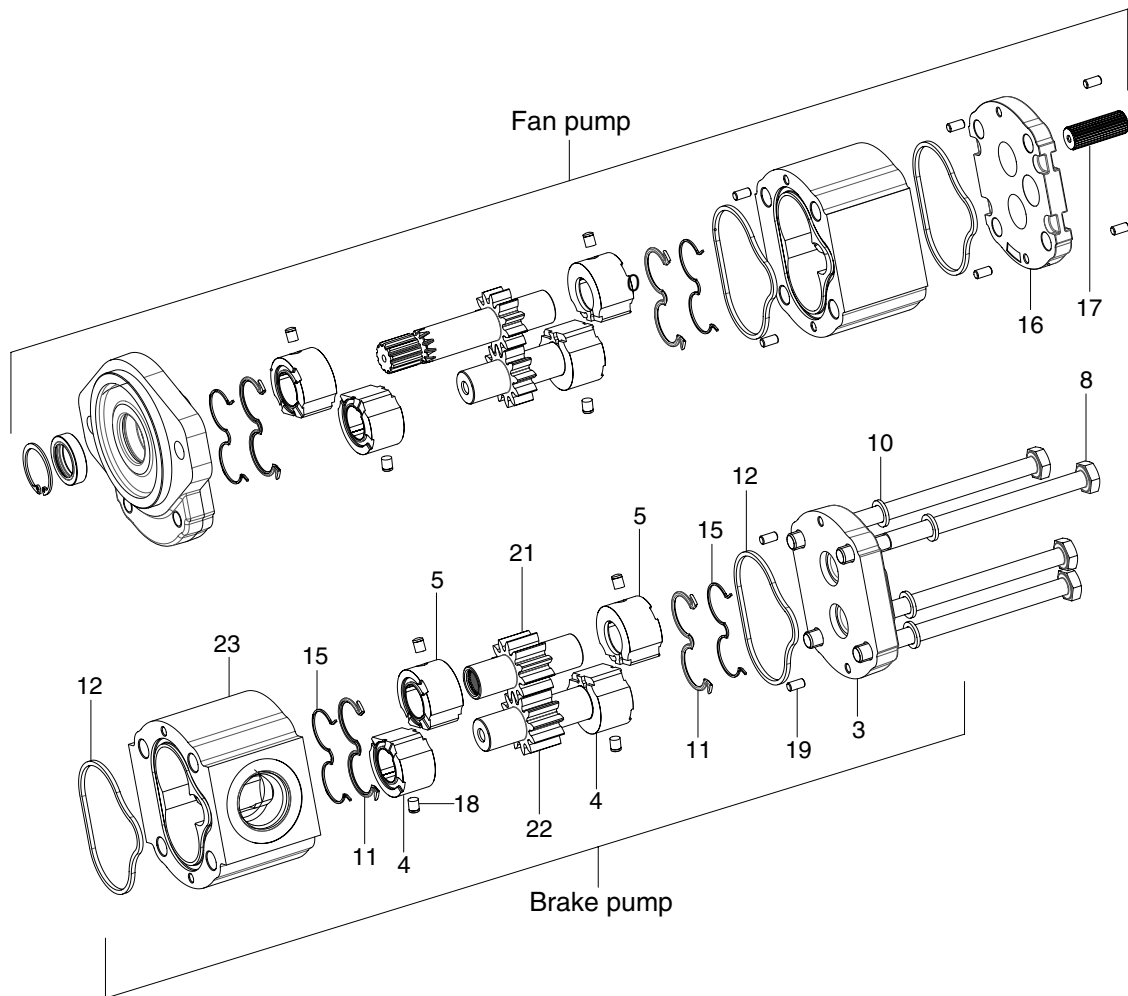
7407ABS19

- (8) Fit shaft(17) to the flange(16).
  - (9) Holding the whole unit together carefully turn it over, making sure it is supported on the spacer flange(16) not the shaft.
  - (10) Slide off the rear over and fit seals as in(5) and (6) above.
  - (11) Fit the rear cover(3), taking care not to dislodge the seal(11) and bolt(8) the unit together.
    - Tightening torque : 7.1kgf · m(51lbf · ft)
- ※ Pour a small amount of oil into a port and check that the shaft can be rotated without undue force using a smooth jawed hand wrench hooked around the shaft or a suitable half coupling locked against the key.

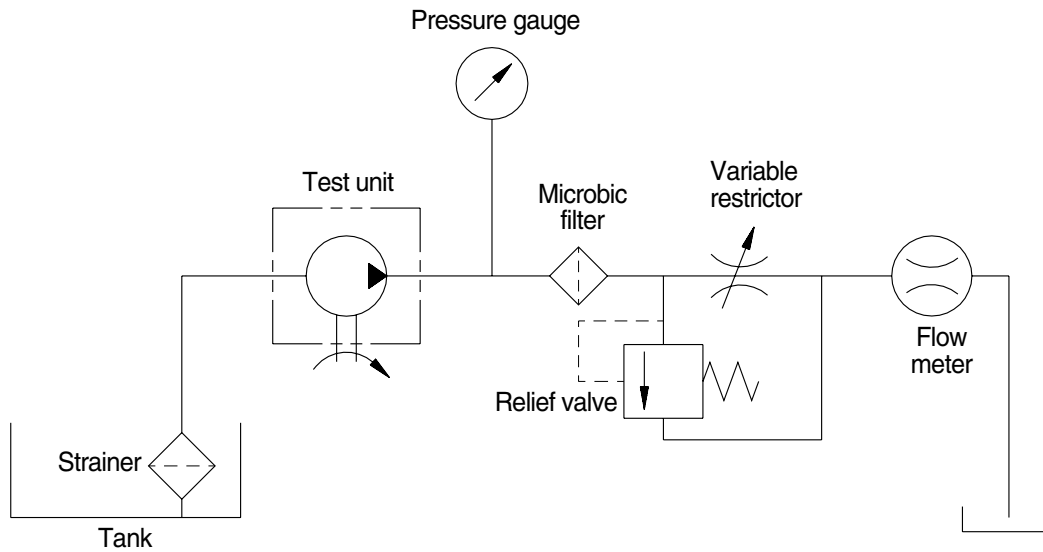
- (1) A unit which has been re-assembled with either new gears, bushes or body, must be carefully run-in before it is subjected to full working conditions.
- (2) Ideally this should be done on a test rig(See figure) where pressure can be gradually applied and any wipings from the body cut-in arrested by filters.
- (3) It is recommended that the unit is run-in at 1500rpm, initially, at zero pressure for one minute then in stages with the pressure increased by 500psi every minute, until maximum rated pressure has been attained. Frequently check the system temperature, ensuring that it does not exceed the maximum permissible figure of 80°C. If the temperature exceeds the system or unit specification the test must be delayed and operated off-load until acceptable temperatures are obtained.
