GROUP 4 DISASSEMBLY AND ASSEMBLY

1. BRAKE PUMP

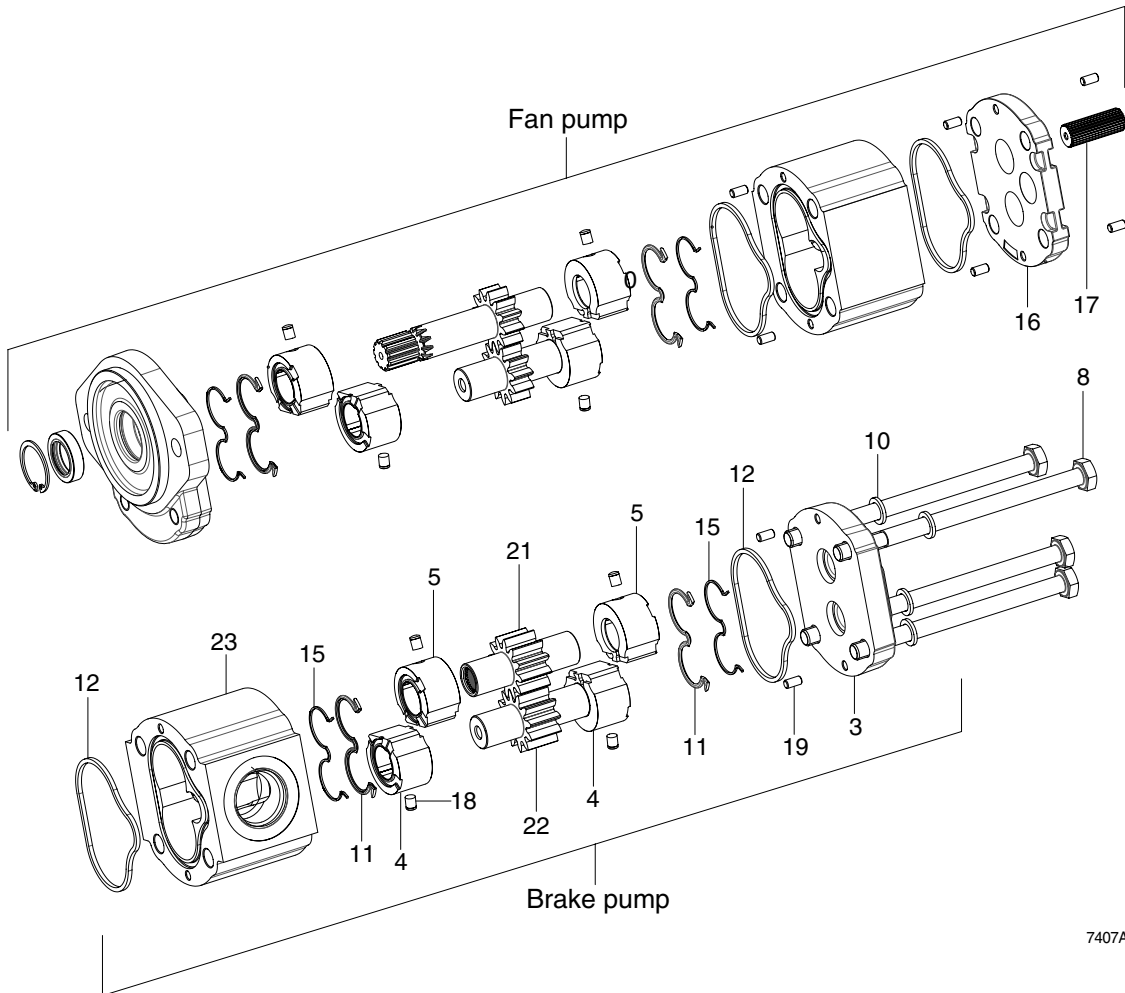
7407ABS19

1) STRUCTURE

| 3 | Rear cover | 11 | Seal | 18 | Spring |
| 4 | Plate | 12 | Seal | 19 | Dowel pin |
| 5 | Plate | 15 | Back up ring | 21 | Drive gear |
| 8 | Screw bolt | 16 | Flange | 22 | Driven gear |
| 10 | Washer | 17 | Shaft | 23 | Body |
