GROUP 4 DISASSEMBLY AND ASSEMBLY

1. BRAKE PUMP

(730TM-3C) 4-48

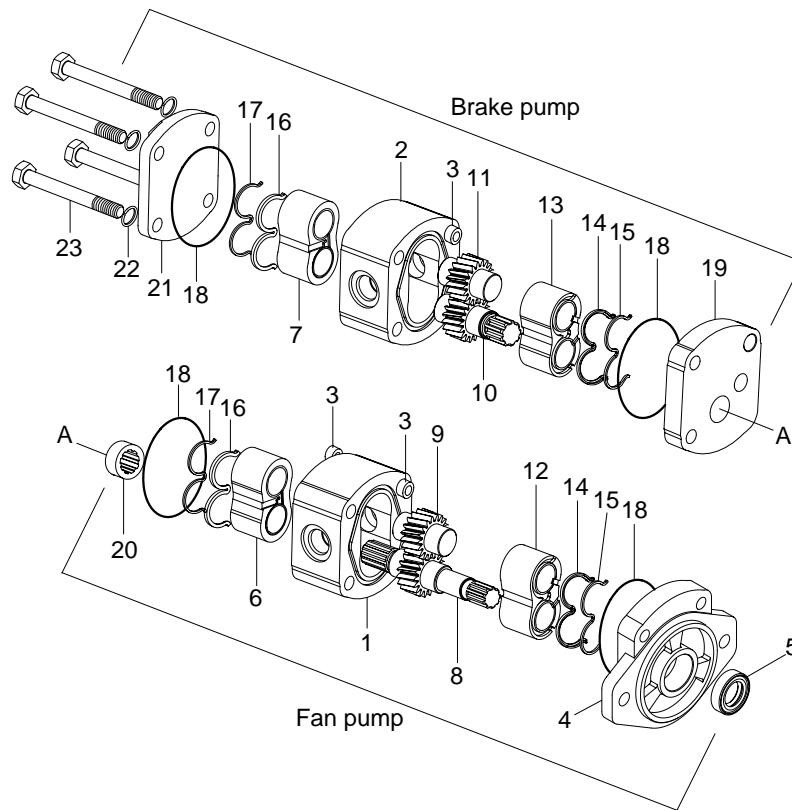
7707BS19

1) STRUCTURE

| 1 | Body | 9 | Driven gear | 17 | Backing ring |
| 2 | Body | 10 | Driver gear | 18 | Body O-ring |
| 3 | Dowel pin | 11 | Driven gear | 19 | Intermediate plate |
| 4 | Front cover | 12 | Bushing | 20 | Coupling |
| 5 | Shaft seal | 13 | Bushing | 21 | Rear cover |
| 6 | Bushing | 14 | Bushing seal | 22 | Spring washer |
| 7 | Bushing | 15 | Backing ring | 23 | Screw |
| 8 | Driver gear | 16 | Bushing seal | | |

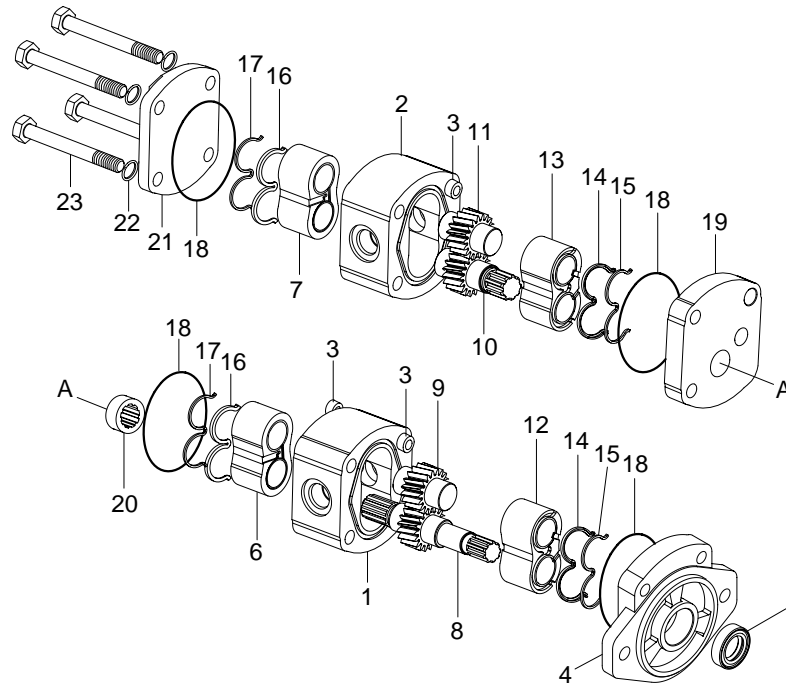
7707BS25

2) DISASSEMBLY

- (1) Lightly mark the rear cover(21), body(2) and plate(19) to ensure reassembly in the correct position.
- (2) Remove the bolts(23) and separate the brake pump unit from the fan pump using a soft faced hammer.

- (3) Remove splined coupling(20).
- (4) Remove the plate(19) from the body(2), free from plate using a soft faced hammer.
- (5) Remove the backing ring(15), the seal element(14) and the body O-ring(18).

- (6) Remove the rear cover(21) from the body(2).
- (7) Remove the backing ring(17), the seal element(16) and the body O-ring(18).
Before removing the internal components each bushing(7, 13) must be marked to denote its location within the body. On the plain area of the bush away from the seal location, lightly mark.

- (8) With the unit laying on its side grasp hold of the drive shaft(10) and pull it squarely out of the body(2) bringing the bushing(13) with it.
- (9) Remove the driven gear(11) and the remaining bushing(7).

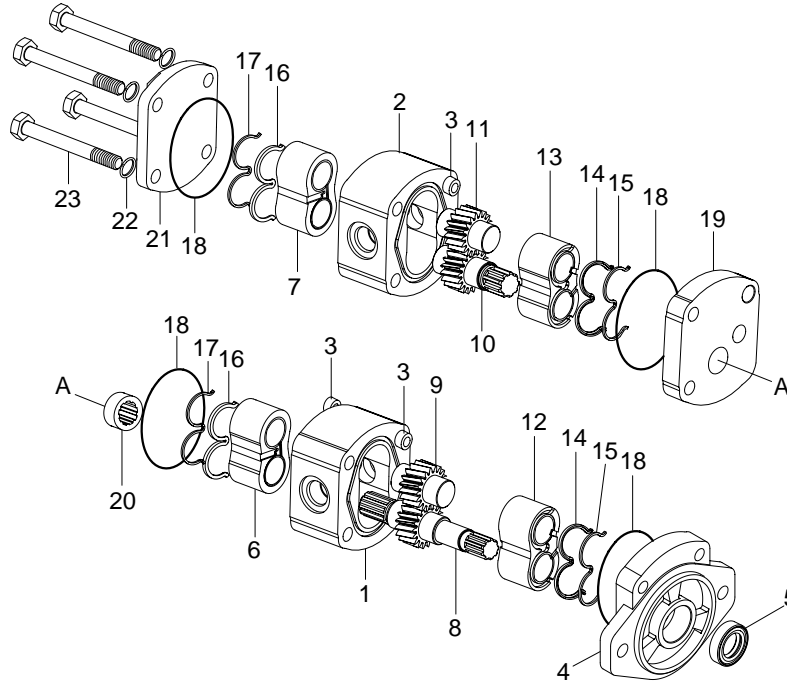
7707BS25

4) ASSEMBLY

Ensure that all parts are perfectly clean and lightly lubricate the bushes and gears with hydraulic oil (Ensure body O-ring recess and end faces remain free from oil). This will assist with their assembly when they are later fitted into the body.

- (1) Refit the bushing(7) into the undowelled end of the body(2) from where they were removed.
- (2) Place the rear cover(21) against the body(2) and then stand the assembly on the cover so that the hollow dowels are uppermost, i.e. the bushing should be at the bottom with the bushings against the cover.
- (3) Fit the drive shaft(10) and driven gear(11) back into their original positions in the body(2).
- (4) Refit the plate bushing(13) into their original bores.
- (5) Fit the new body O-ring(18).
- (6) Fit the new seal element(14) and backing ring(15) to the bushing.
- (7) Carefully refit the plate(19) to the body(2). If the plate(19) is not fitted squarely the backup seal(14) may become misplaced and trapped, resulting in internal damage if the unit is run in this condition.

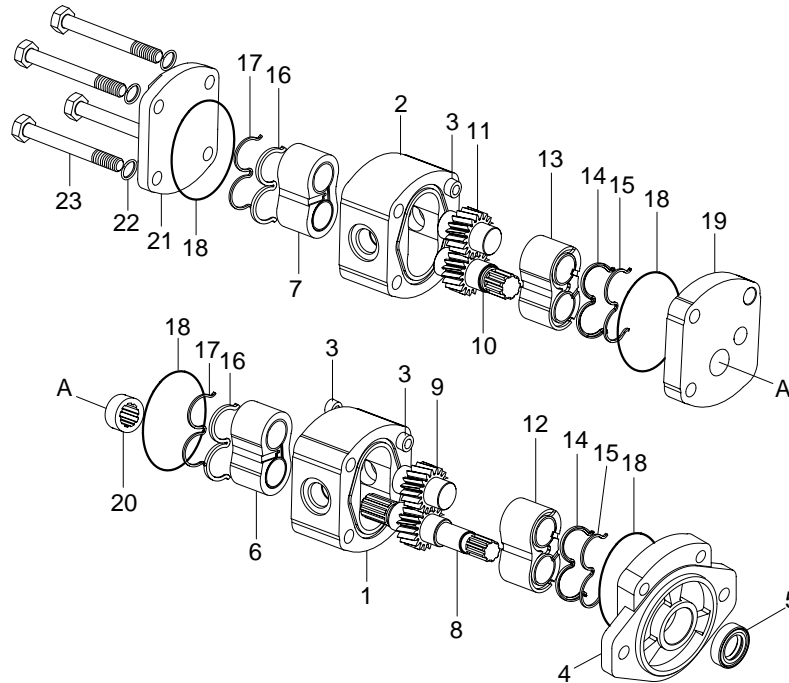
7707BS25

ASSEMBLY

- (8) Fit coupling(20) to the plate(19).
- (9) Holding the whole unit together carefully turn it over, making sure it is supported on the spacer plate(19) not the shaft.
- (10) Slide off the rear over and fit seals as in(5) and (6) above.
- (11) Fit the rear cover(21), taking care not to dislodge the backup seal(16) and bolt(23) the unit together.
 - Tightening torque : 4.8kgf · m(35lb · ft)Pour a small amount of oil into a port and check that the shaft can be rotated without undue force using a smooth jawed hand wrench hooked around the shaft or a suitable half coupling locked against the key.

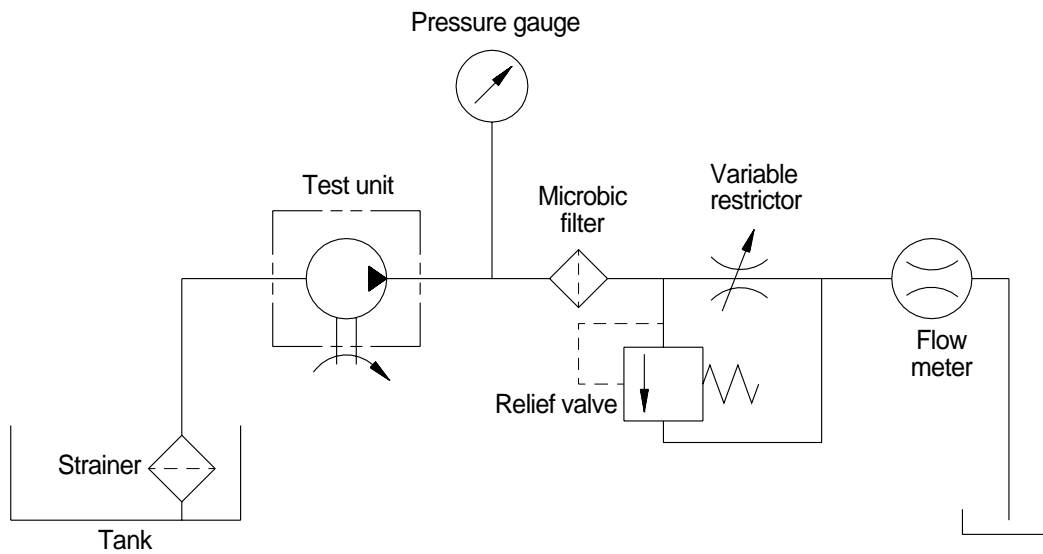
5) RUNNING-IN

- (1) A unit which has been re-assembled with either new gears, bushes or body, must be carefully run-in before it is subjected to full working conditions.
- (2) Ideally this should be done on a test rig(See figure) where pressure can be gradually applied and any wipings from the body cut-in arrested by filters.
- (3) It is recommended that the unit is run-in at 1500rpm, initially, at zero pressure for one minute then in stages with the pressure increased by 500psi every minute, until maximum rated pressure has been attained. Frequently check the system temperature, ensuring that it does not exceed the maximum permissible figure of 80 °C. If the temperature exceeds the system or unit specification the test must be delayed and operated off-load until acceptable temperatures are obtained.
