GROUP 4 DISASSEMBLY AND ASSEMBLY

1. BRAKE PUMP

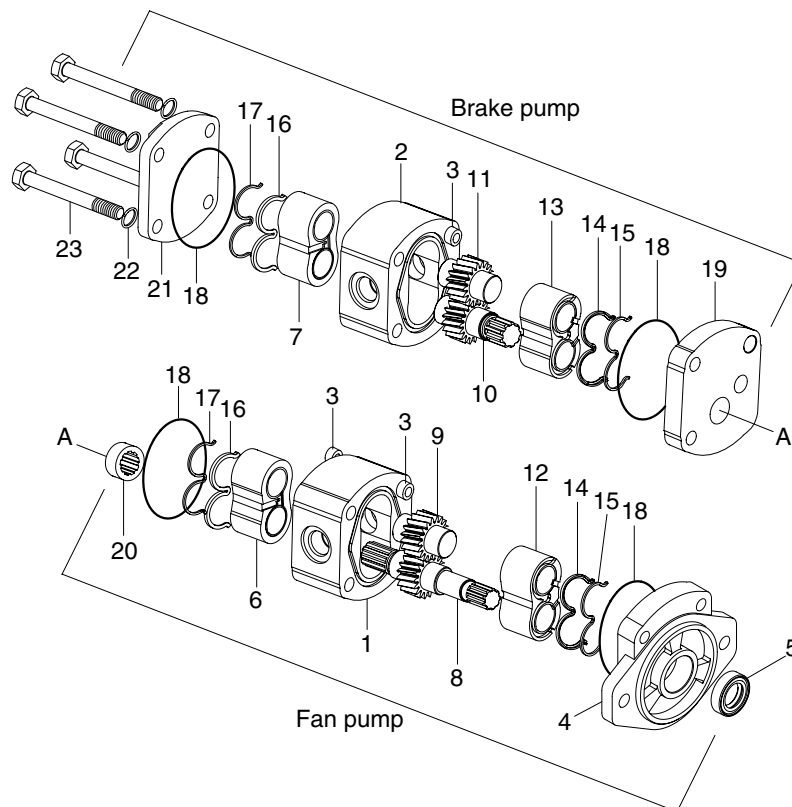
7707BS19

1) STRUCTURE

1	Body	9	Driven gear	17	Backing ring
2	Body	10	Driver gear	18	Body O-ring
3	Dowel pin	11	Driven gear	19	Intermediate plate
4	Front cover	12	Bushing	20	Coupling
5	Shaft seal	13	Bushing	21	Rear cover
6	Bushing	14	Bushing seal	22	Spring washer
7	Bushing	15	Backing ring	23	Screw
8	Driver gear	16	Bushing seal

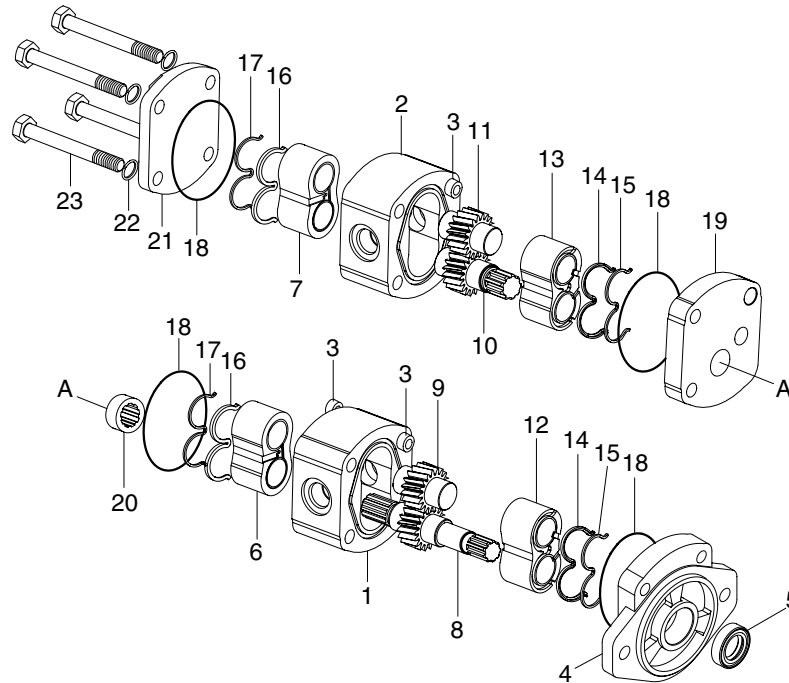
7707BS25

2) DISASSEMBLY

- (1) Lightly mark the rear cover(21), body(2) and plate(19) to ensure reassembly in the correct position.
- (2) Remove the bolts(23) and separate the brake pump unit from the fan pump using a soft faced hammer.

- (3) Remove splined coupling(20).
- (4) Remove the plate(19) from the body(2), free from plate using a soft faced hammer.
- (5) Remove the backing ring(15), the seal element(14) and the body O-ring(18).

- (6) Remove the rear cover(21) from the body(2).
- (7) Remove the backing ring(17), the seal element(16) and the body O-ring(18).
※ Before removing the internal components each bushing(7, 13) must be marked to denote its location within the body. On the plain area of the bush away from the seal location, lightly mark.

- (8) With the unit laying on its side grasp hold of the drive shaft(10) and pull it squarely out of the body(2) bringing the bushing(13) with it.
- (9) Remove the driven gear(11) and the remaining bushing(7).

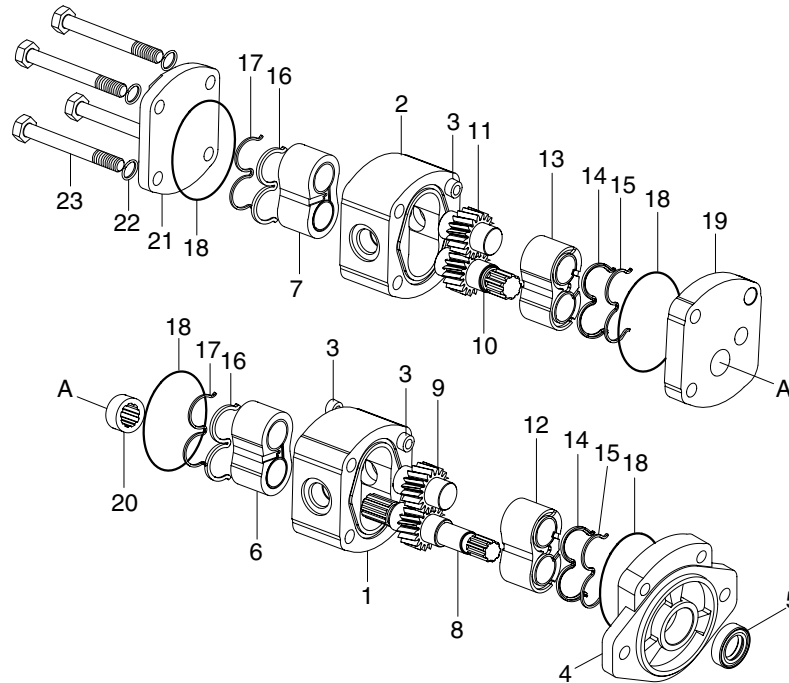
7707BS25

4) ASSEMBLY

※ Ensure that all parts are perfectly clean and lightly lubricate the bushes and gears with hydraulic oil(Ensure body O-ring recess and end faces remain free from oil). This will assist with their assembly when they are later fitted into the body.

- (1) Refit the bushing(7) into the undowelled end of the body(2) from where they were removed.
- (2) Place the rear cover(21) against the body(2) and then stand the assembly on the cover so that the hollow dowels are uppermost, i.e. the bushing should be at the bottom with the bushings against the cover.
- (3) Fit the drive shaft(10) and driven gear(11) back into their original positions in the body(2).
- (4) Refit the plate bushing(13) into their original bores.
- (5) Fit the new body O-ring(18).
- (6) Fit the new seal element(14) and backing ring(15) to the bushing.
- (7) Carefully refit the plate(19) to the body(2). If the plate(19) is not fitted squarely the backup seal(14) may become misplaced and trapped, resulting in internal damage if the unit is run in this condition.

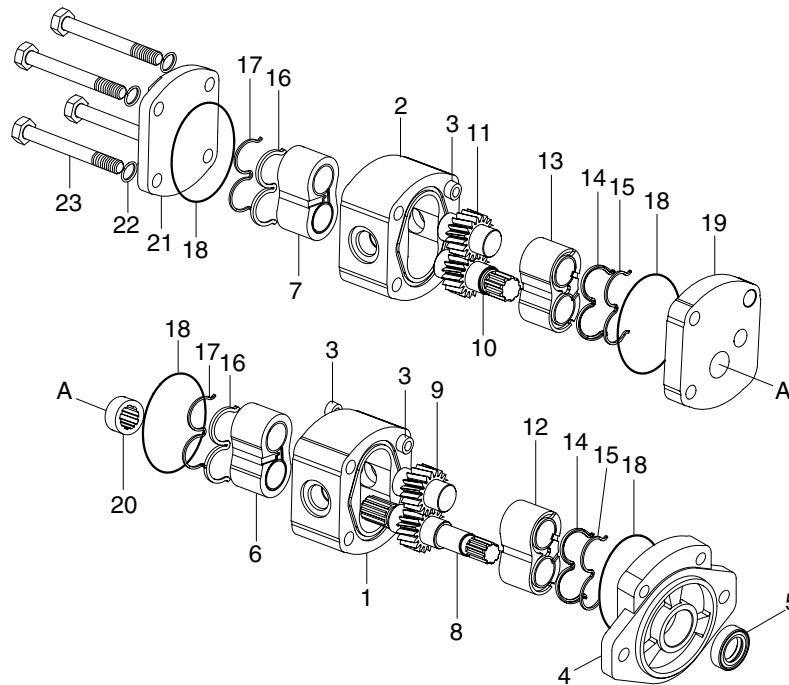
7707BS25

- (8) Fit coupling(20) to the plate(19).
 - (9) Holding the whole unit together carefully turn it over, making sure it is supported on the spacer plate(19) not the shaft.
 - (10) Slide off the rear over and fit seals as in(5) and (6) above.
 - (11) Fit the rear cover(21), taking care not to dislodge the backup seal(16) and bolt(23) the unit together.
 - Tightening torque : 4.8kgf · m(35lbf · ft)
- ※ Pour a small amount of oil into a port and check that the shaft can be rotated without undue force using a smooth jawed hand wrench hooked around the shaft or a suitable half coupling locked against the key.

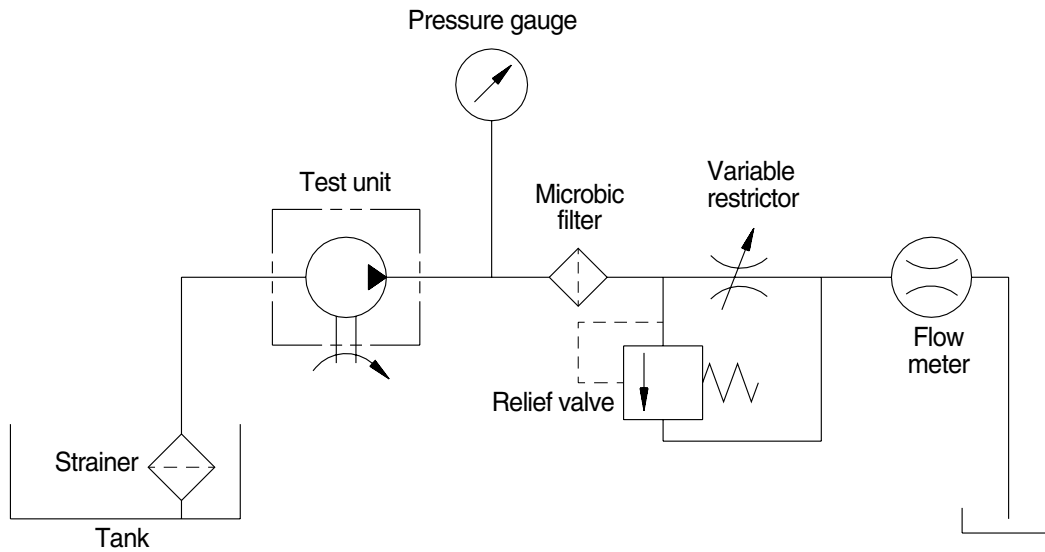
5) RUNNING-IN

- (1) A unit which has been re-assembled with either new gears, bushes or body, must be carefully run-in before it is subjected to full working conditions.
- (2) Ideally this should be done on a test rig(See figure) where pressure can be gradually applied and any wipings from the body cut-in arrested by filters.
- (3) It is recommended that the unit is run-in at 1500rpm, initially, at zero pressure for one minute then in stages with the pressure increased by 500psi every minute, until maximum rated pressure has been attained. Frequently check the system temperature, ensuring that it does not exceed the maximum permissible figure of 80°C. If the temperature exceeds the system or unit specification the test must be delayed and operated off-load until acceptable temperatures are obtained.
